**UNDERGROUND FACTORIES
IN GERMANY**

UNDERGROUND FACTORIES IN GERMANY

C.I.O.S. Party 536.

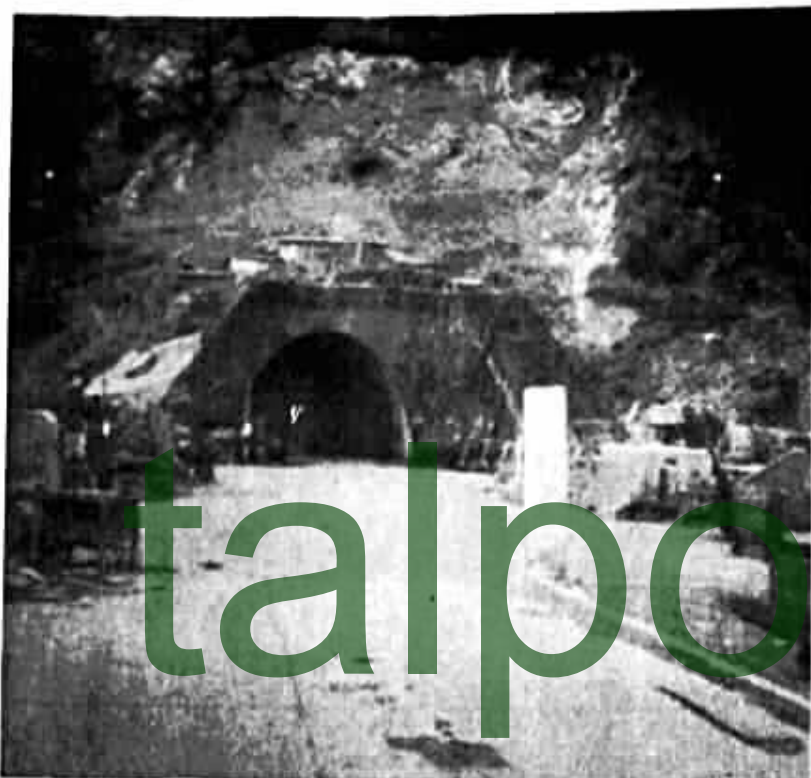
PHOTOGRAPH No.2.

Mittelwerke,
Neidersachswerfen.

Tunnel entrance "C"

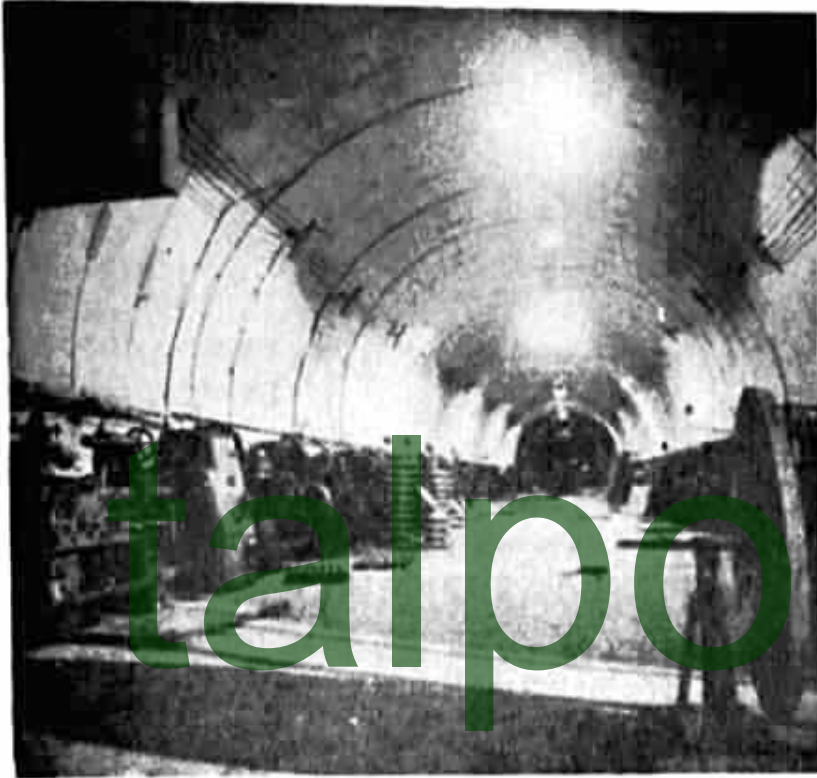
PHOTOGRAPH No.4.

Langenstein.
Cross Gallery.

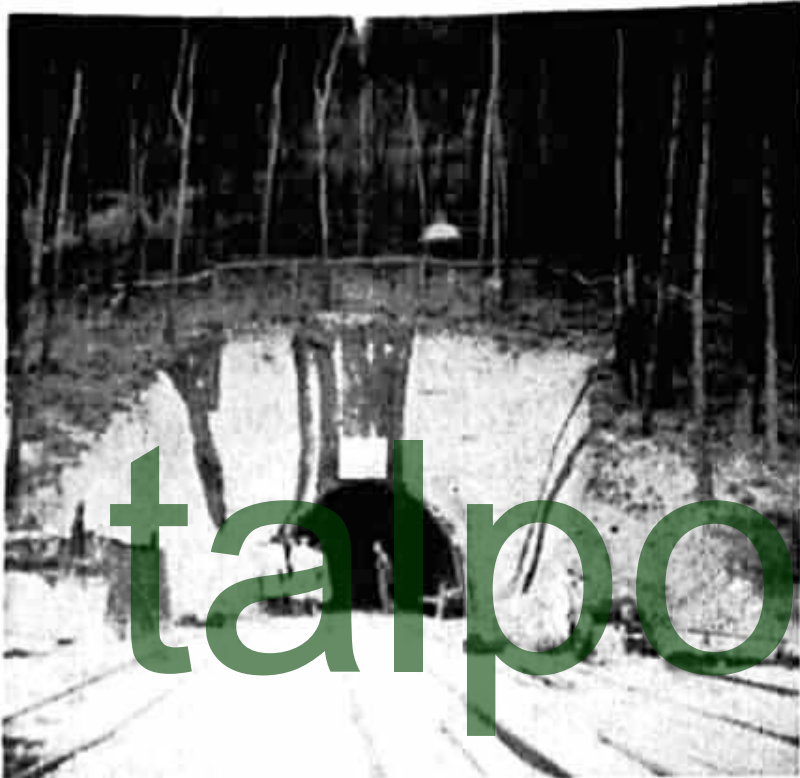
PHOTOGRAPH No.6.

Malachit,
Langenstein.

Entrance "D".

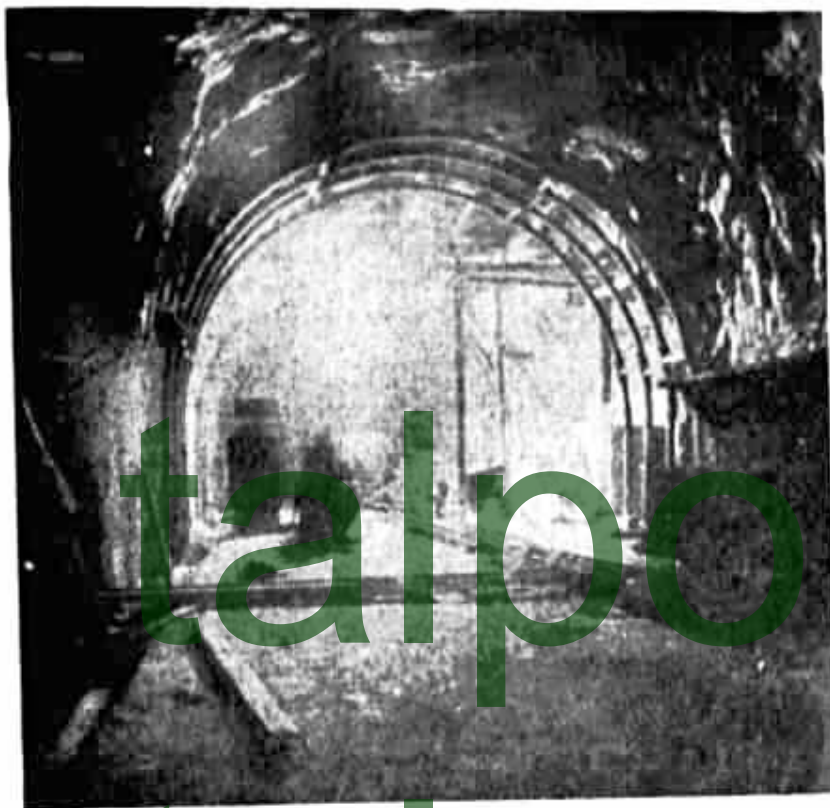
PHOTOGRAPH No.8.

Malachit,
Langenstein.

Concrete lining
in progress.

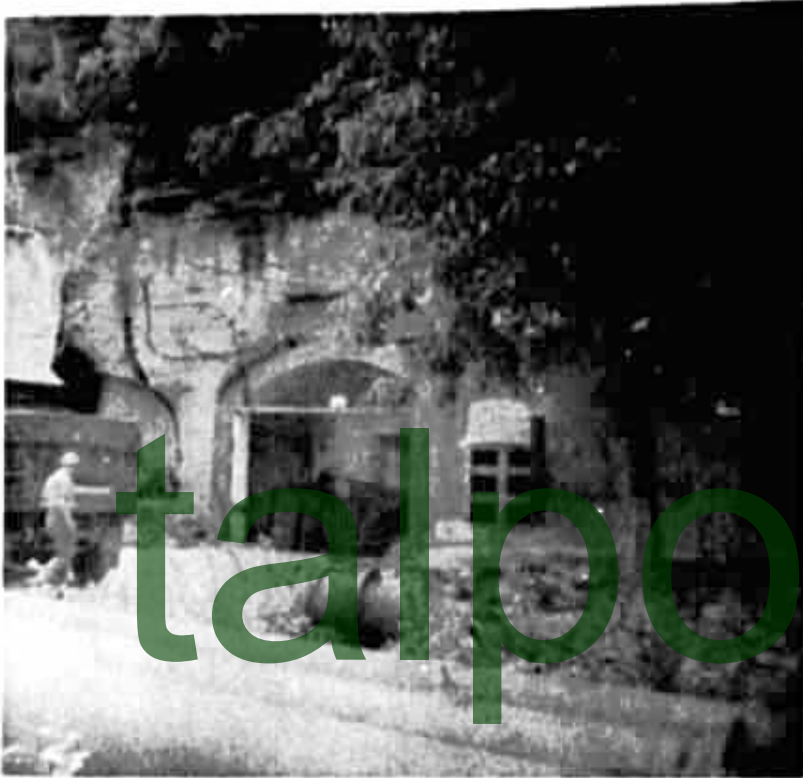
PHOTOGRAPH No.12.

Makrele I.
Halberstadt.

Entrance to
Champignon caves.

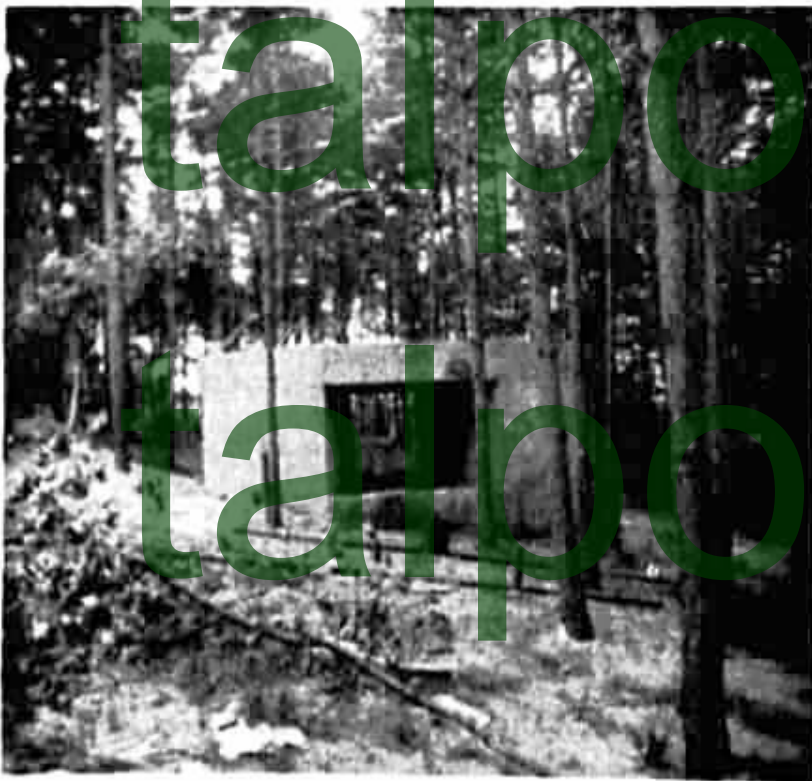
PHOTOGRAPH No.13.

Makrele I.
Halberstadt.

Protection to
ventilation shaft.

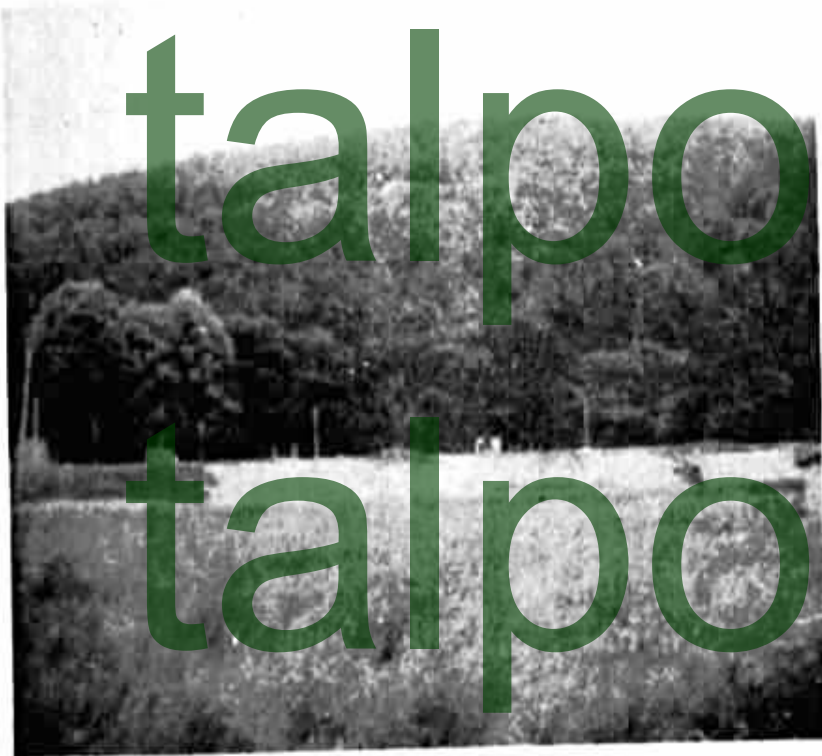
PHOTOGRAPH No. 14.

Elben.

Camouflaged spoil
dump.

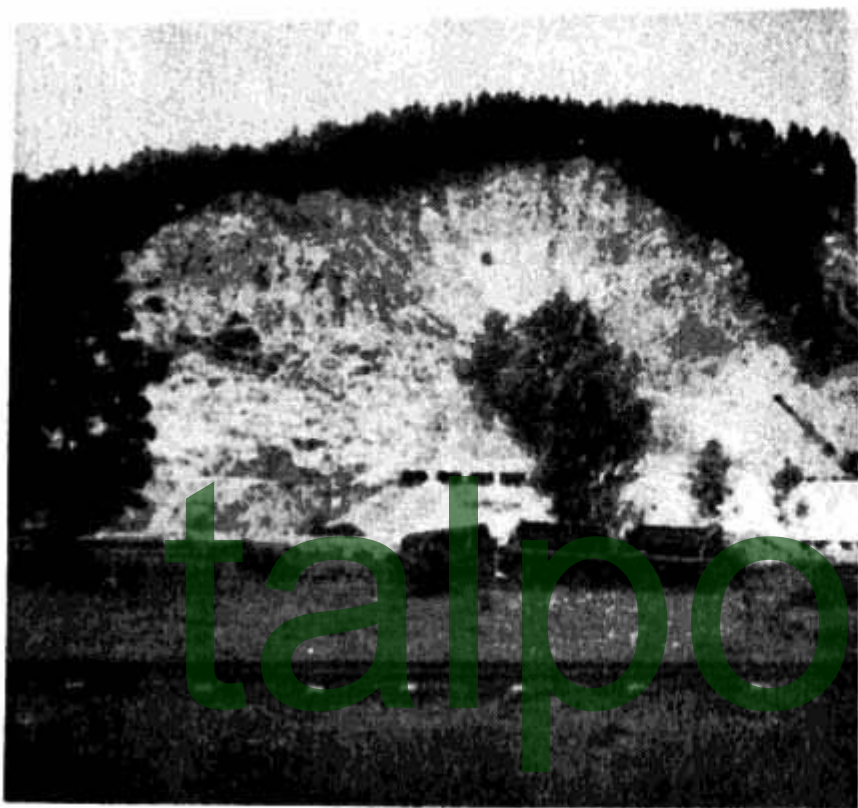
PHOTOGRAPH No.15.

Dechs IV,
Osterode.

Anhydrite quarry.

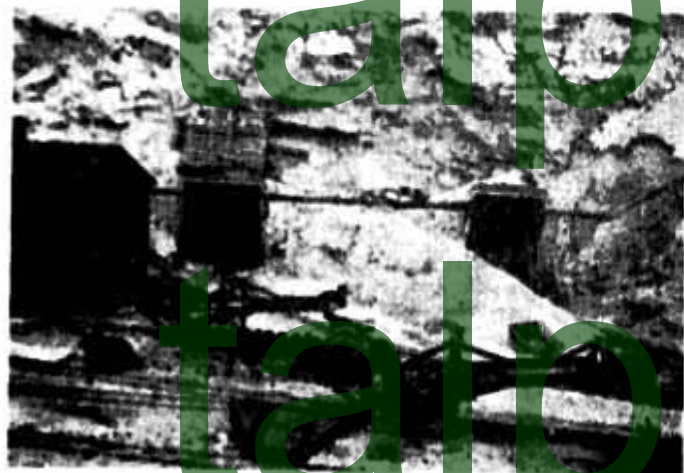
PHOTOGRAPH No.16.

Dechs IV,
Osterode.

Entrance to workings.

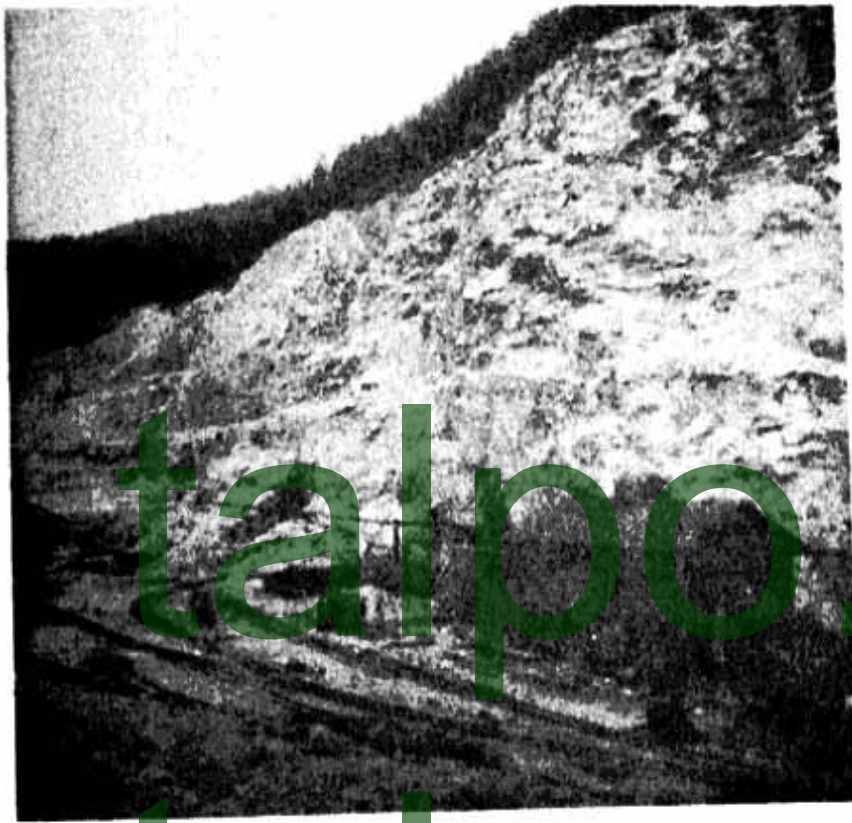
PHOTOGRAPH No.17.

Dachs IV,
Osterode.

Anhydrite quarry,
compressor plant
in foreground.

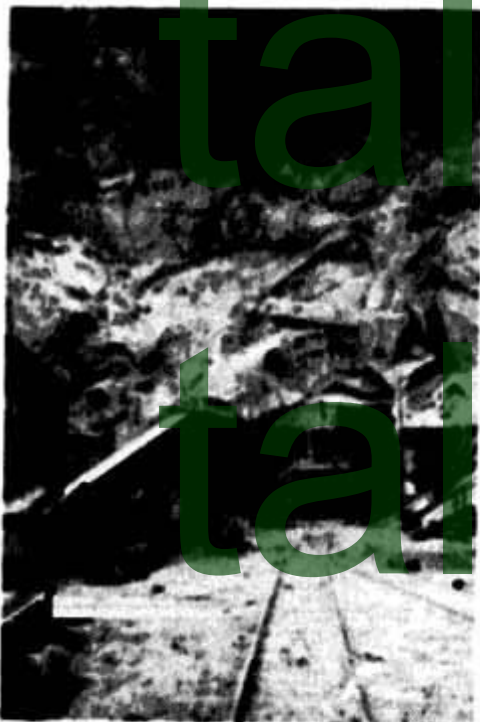
PHOTOGRAPH No.19.

Odawerke,
Regenstein.

Entrance to workings.

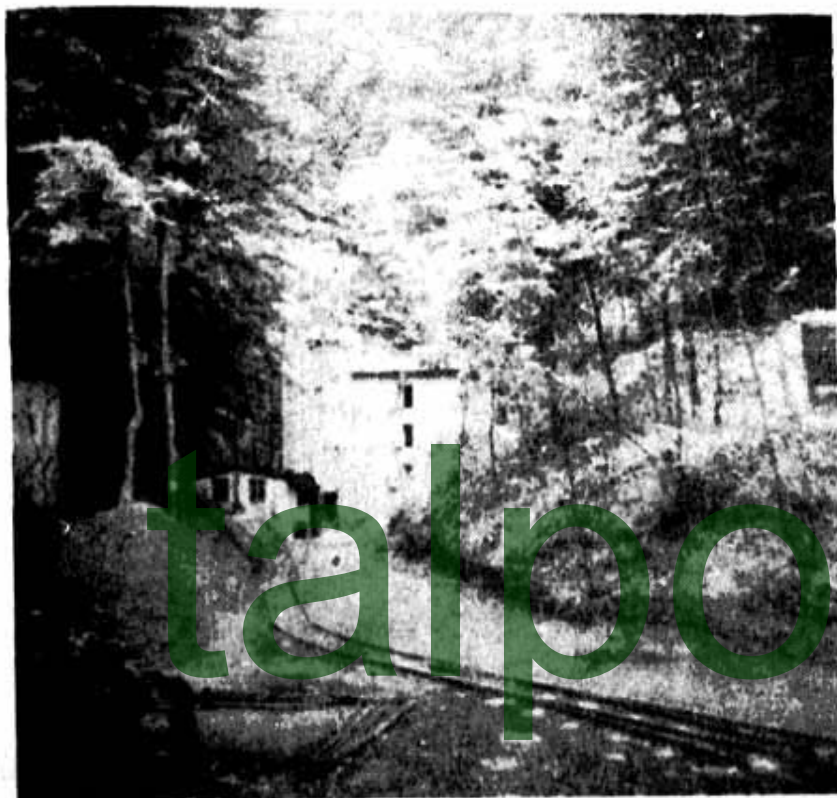
PHOTOGRAPH No.20.

Denkmal Stollen,
Berkhausen.

Entrance to
factory, showing
blast well.

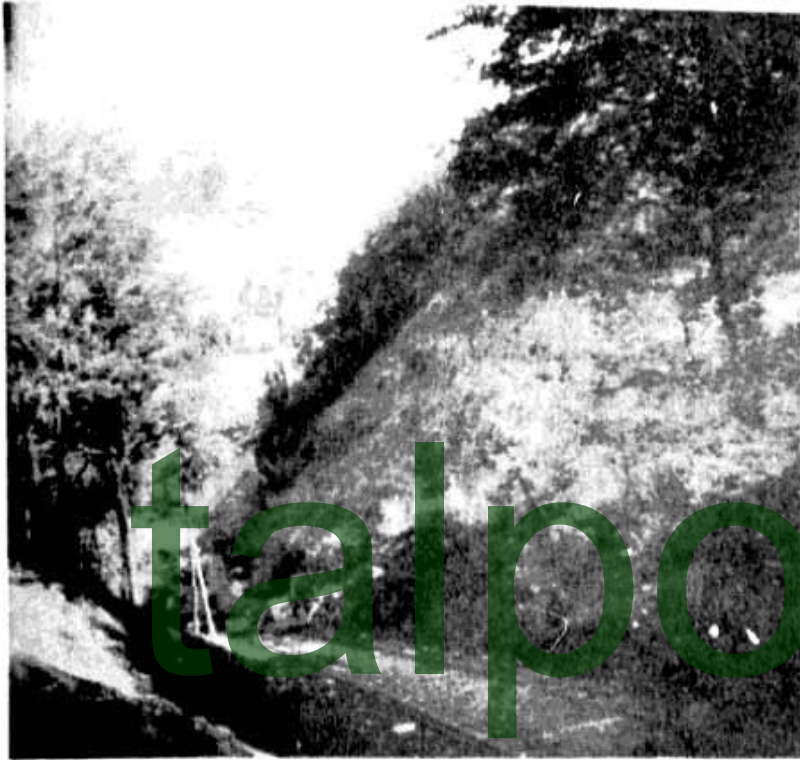
PHOTOGRAPH No. 26.

Hammerwerke,
Porta Westfalica.
Funicular railway from
the entrance to
Hammerwerke. Entrance
to Dachs I below,
River Weser in
distance.

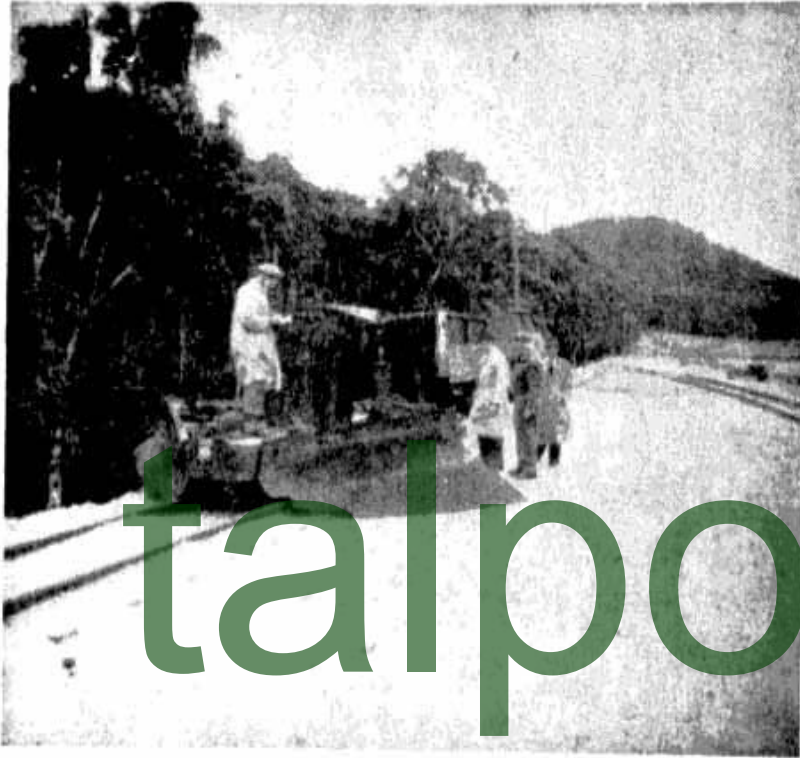
PHOTOGRAPH No.28

Langenstein
Spoil spreader
on dump.

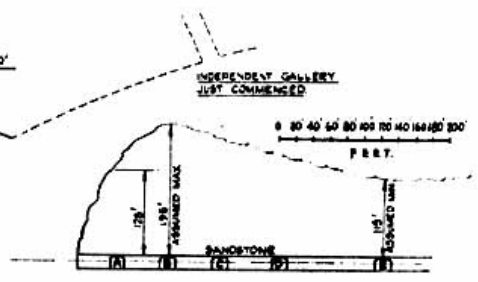
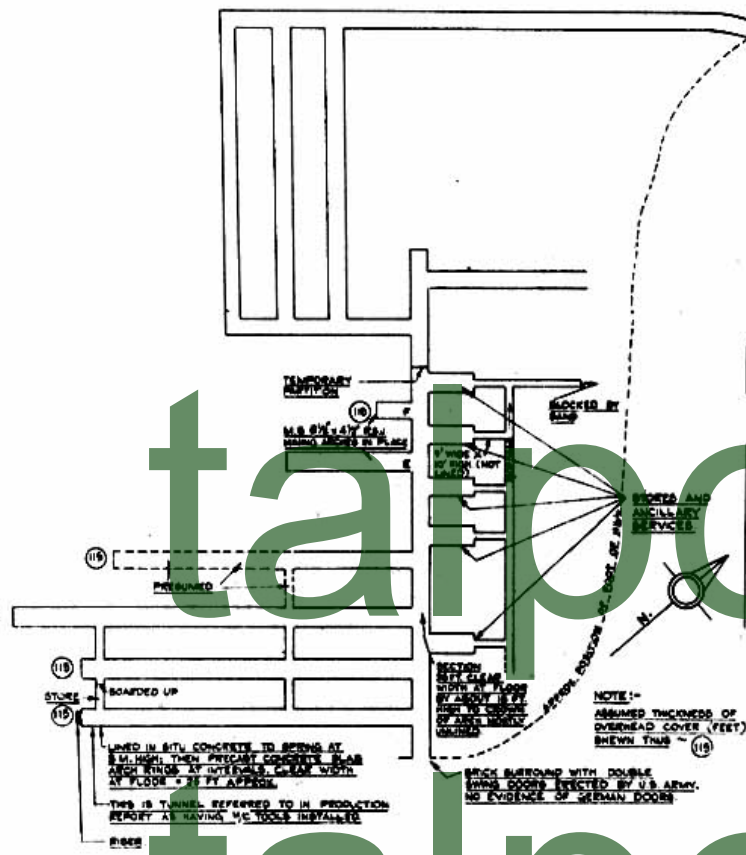
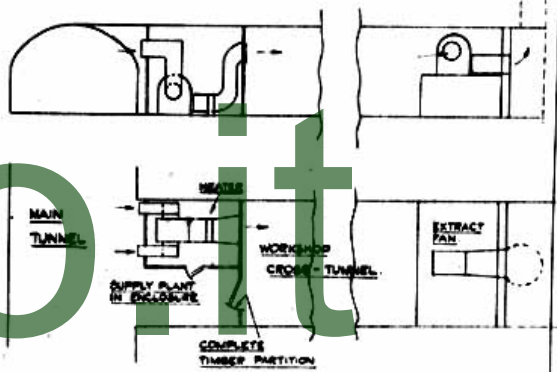
NAME OF FACTORY - **REGENSTEIN NR BLANKENBURG**
 CODE NAME - ODA-WERKE. **LA**

LINED IN SITU CONCRETE TO SPRING AT 134' HIGH. THEN PRECAST CONCRETE SLAB ARCH RINGS AT INTERVALS. CLEAR WIDTH AT FLOOR = 27 FT APPROX.
 THIS IS TUNNEL REFERRED TO IN PRODUCTION REPORT AS HAVING MC TOOLS INSTALLED

BRICK SURROUND WITH DOUBLE SWING DOORS ERECTED BY U.S. ARMY. NO EVIDENCE OF GERMAN DOORS
